REC-ERC-82-2

INSTALLATION OF FLEXIBLE MEMBRANE LINING IN MT. ELBERT FOREBAY RESERVOIR

September 1981

**U.S. Department of the Interior
Bureau of Reclamation**

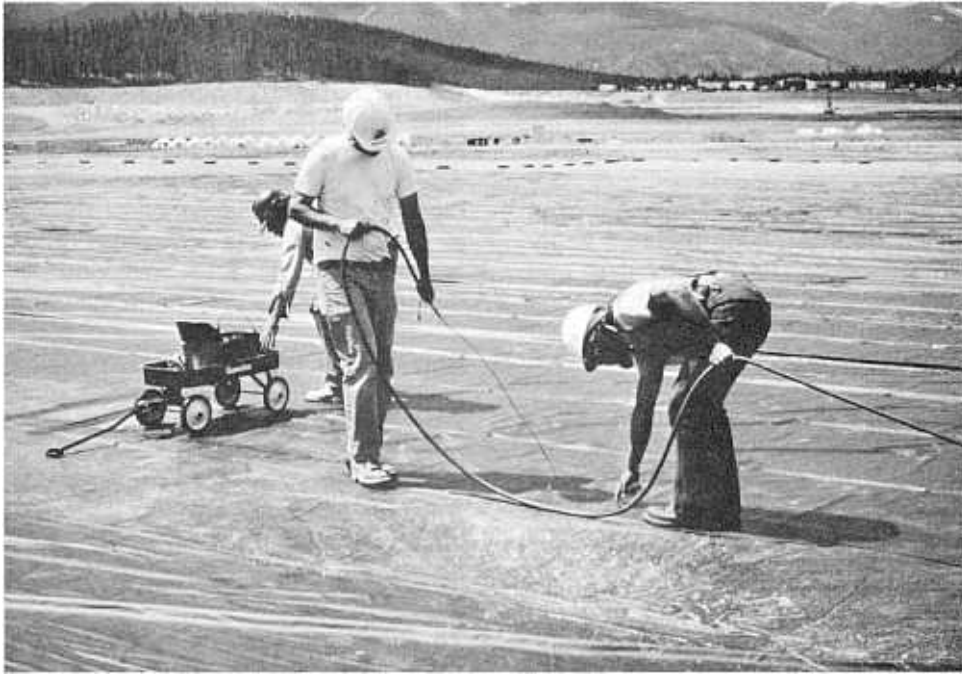
Figure 30.— Air-testing field seams. Photo P-801-D-79746

examined for any defects or punctures that required patching (fig. 38). The seaming of the blankets was monitored closely to ensure that the minimum 100-mm (4-in) wide seam was produced. After the field seams were completed and allowed to cure, they were air tested. Any defective or unbonded areas were marked and repaired prior to application of the cap strip. The air lance test was invaluable and should be specified for all jobs involving similar lining materials.

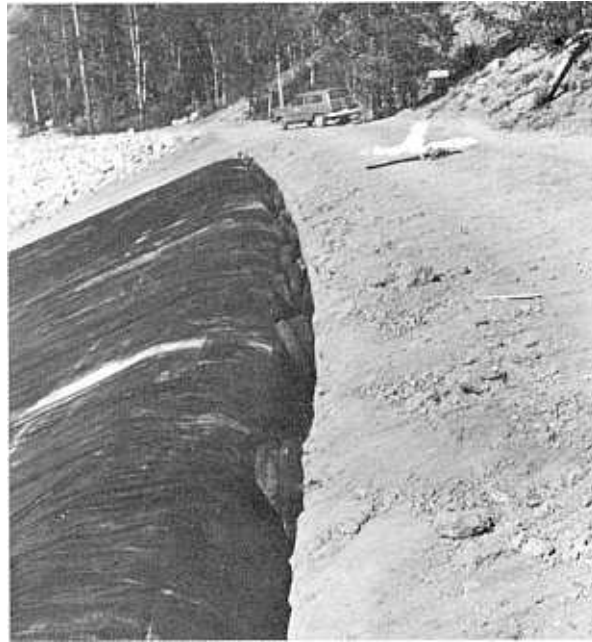
Figure 33.—Membrane lining temporarily anchored with rubber tires prior to backfilling. Photo P-382-706-28163 NA

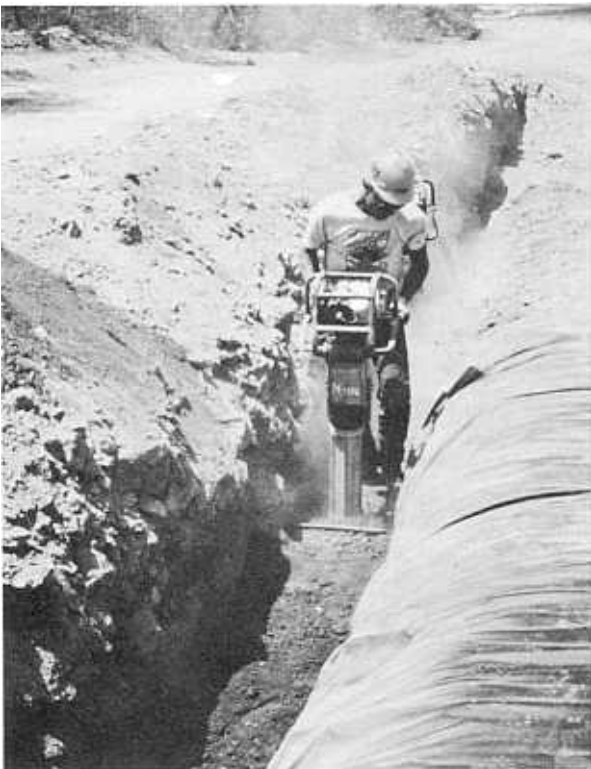
Figure 34.—Compaction of the backfill material in the anchor trench. This portion of the anchor trench was in the perimeter of the access road (top of photograph). This type of compaction may result in less stress on the liner than compaction by the wheels of the construction equipment. Photo P-801-D-79748

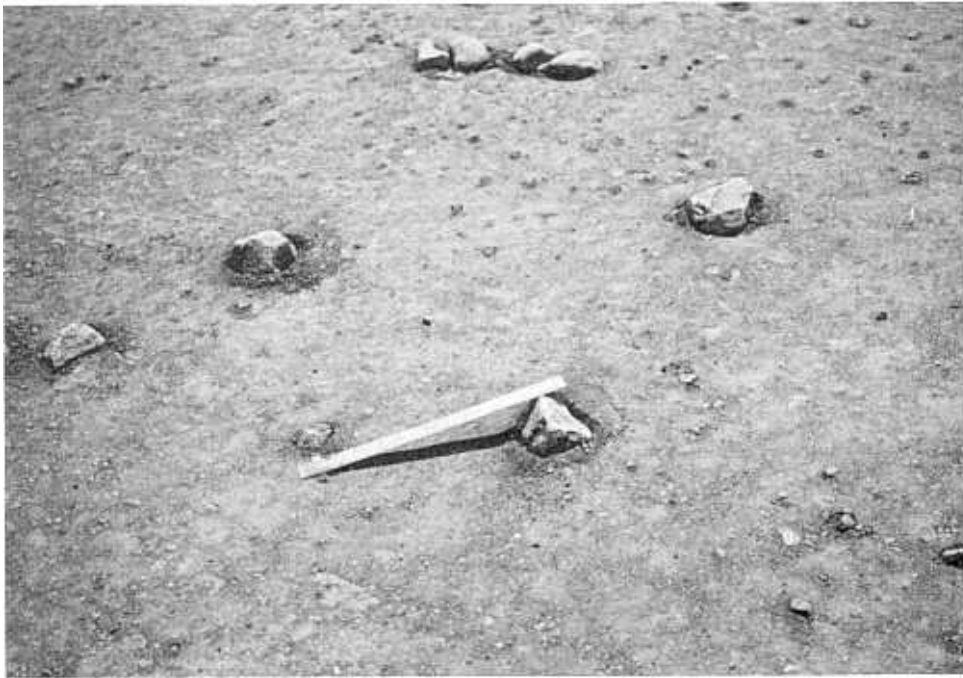
blanket. A test section of CPER was then placed over the aggregate and 0.56 m (22 in) of loose, processed cover material was spread over the blanket section. The cover material was then compacted to a 0.46-m (18-in) depth with six passes of a fully loaded 651 Caterpillar scraper/loader, which resulted in a wheel loading of approximately 310 kPa (45 lb/in²) and an average density of 1362 kg/m³ (85 lb/ft³) (slightly lower than the average density obtained during actual cover placement). The cover material was then removed and the lining test section was inspected for physical damage (fig. 40). Preliminary visual inspection of the liner indicated that neither puncturing nor tearing had occurred; however, the lining was obviously stressed over the aggregate (fig. 41). Figure 42 indicates the varying size and spacing between the aggregate.

Figure 42.—Typical size and spacing of aggregate placed under the membrane lining test section.
Photo P-801-D-79753

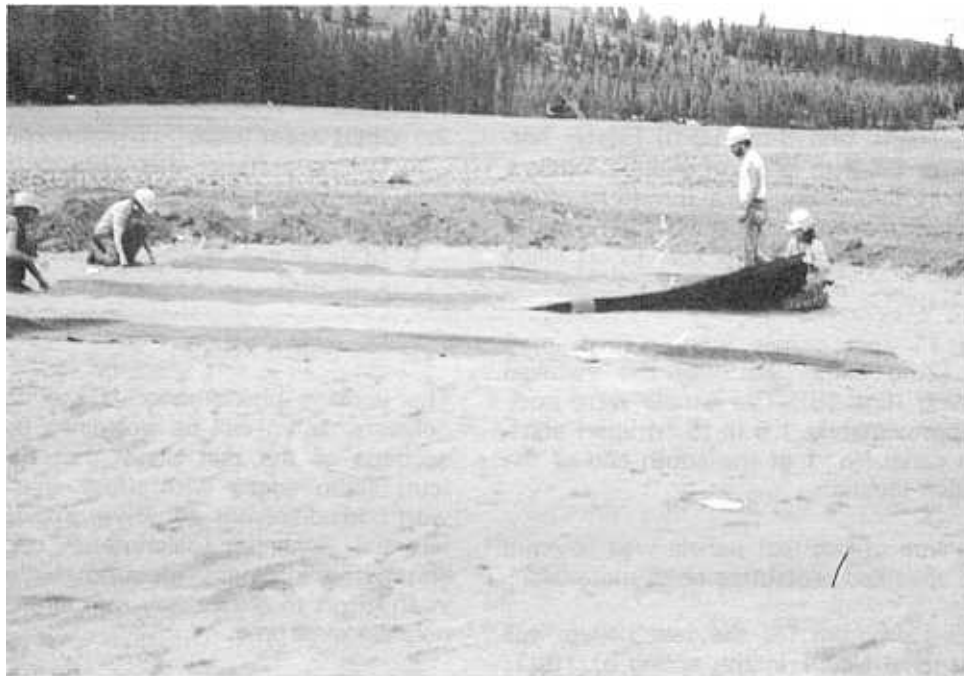
6. The 11 test panels were placed on a 50-mm (2-in) sand bed over the installed CPER lining (fig. 48). The panels were positioned approximately 1.5 m (5 ft) apart starting with panel No. 1 at the south end of the test section location.

Figure 48.—Installing CPER test panels over sand bedding in field test section. Photo P-801-D-79758
